## ASIC/2 Clock Chip End-of-Life Notice

Affects: ASIC/2-8040, -7040, SINC/3, SINC/2

Date: 11 February 2008

**TechNote: TN-038**

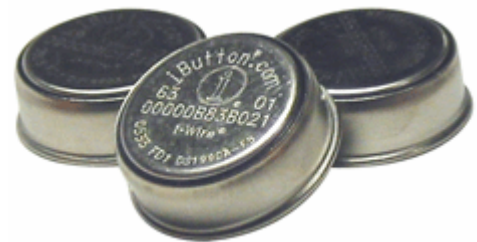
We have been advised by the chip manufacturer that the Dallas Clock Chip (DS1994L-F5 non-RoHS, DS1994L-F5+ RoHS) is no longer being manufactured. It is "End-of-Life" and the recommended replacement chip is not compatible. Replacements are available today. They will be hard to find later.

We suggest you evaluate your usage of older ASIC/2 controllers and consider replacing critical clock chips during routine preventative maintenance while replacements are still available. When replacements are no longer available, clock chip failure may result in having to replace the controller.
