## Two-Part Screw Terminal Connectors

Affects: ASIC/1-8655, ASIC/2-8540

Date: 16 April 2008

Note No. TN-039

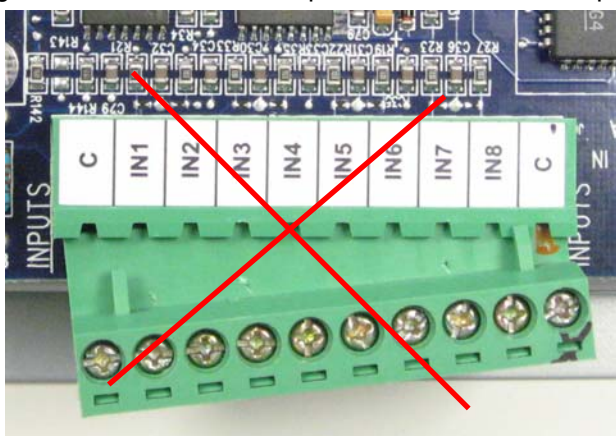
We have observed this on-site at one installation. On examining the “bad” plug connector, we find that indeed the female connector that grips the male header pin on position 1 or position 10 has been forced open, so that it no longer makes proper contact.

The problem appears to be caused when the two-part connector is unplugged. Considerable force is required. If one end is forced out at an angle, this can bend the end position contacts on the plug,

**Incorrect !!!**

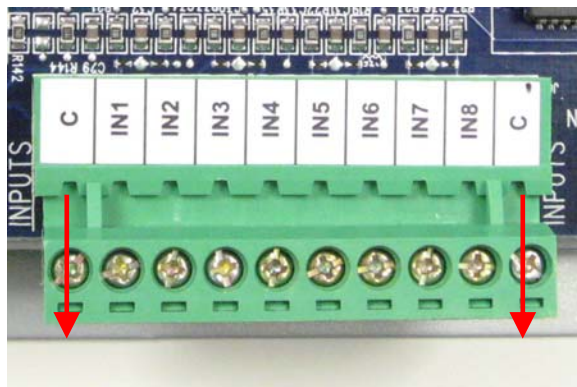
**Correct !!**

Care must be taken when unplugging the connectors in the field or on the bench. Use two thumbs to push the connector out from both sides so that it comes out evenly.
