## ASIC/1-6000 Floating Actuator Problem

Affects: ASIC/1-6000, -PD, -MB, -MB-PD

Date: 20 June 2008

**Note No. TN-040**

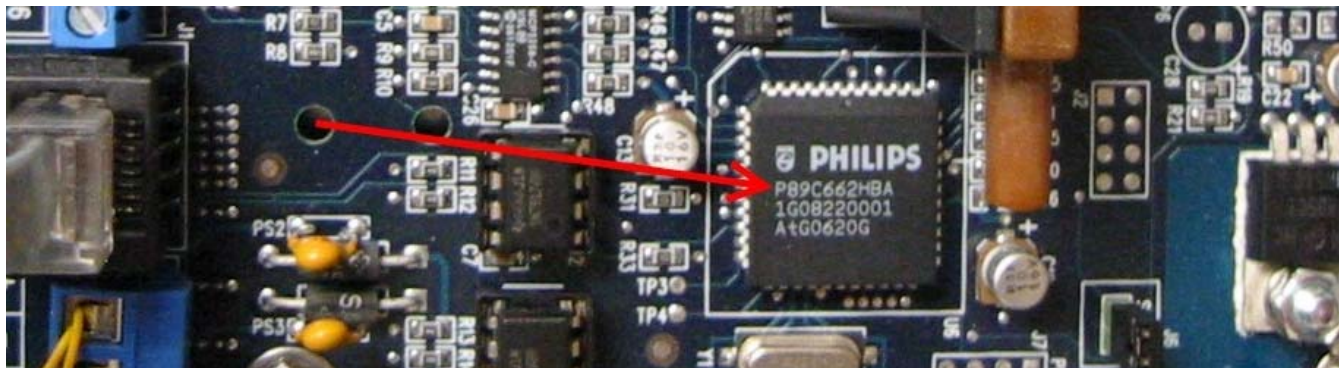
We began shipping a portion of ASIC/1-6000 controllers with a newer ("green"), lead-free processor subsequent to February 1, 2008. The newer processor can be identified by looking at the Philips P89 chip on the circuit board (U6). Chips beginning with "P89V" are the newer "green" processors; chips beginning with "P89C" are the older processors. Two images are provided below to help you identify which processor your controllers uses. Our testing has not found any problems with the P89C processors.

Older processor P89C

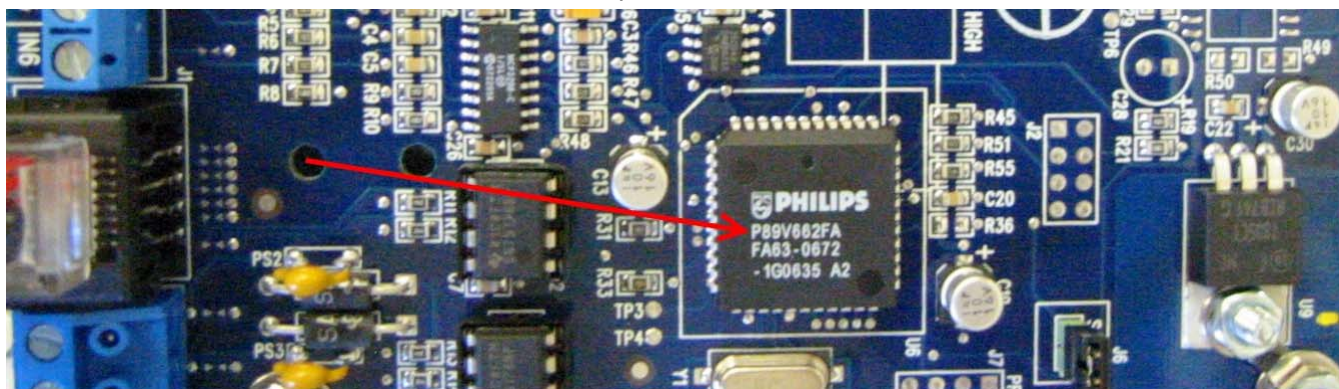
We have identified a possible problem when using newer (2008 model) ASIC/1-6000 controllers with a floating (tri-state) hot water valve actuator. It appears to be caused by the new ROHS or lead free "green" version of the microprocessor.

We received a report from one customer that some ASIC/1-6000 controllers would stop communicating and controlling within 24 hours. We have since found in testing that this problem occurs with controllers using a new "green" processor and certain floating hot water valve actuators controlled by outputs 3 and 4. Our testing has not found any problem when using relays connected to outputs 3, 4 or 5 or when positioning the integral damper actuator using outputs 1 and 2. No problems have been found when using the analog output to position a hot water valve actuator either.

Newer (green) processor P89V

Please contact Technical Support at 925-866-8808 (option 3) if you have controllers using P89V processors and floating hot water valve actuators.
