Power Fuse on ASIC/2-8040

Effects: ASIC/2-8040

Date: July 7, 1998

Note No. TE014

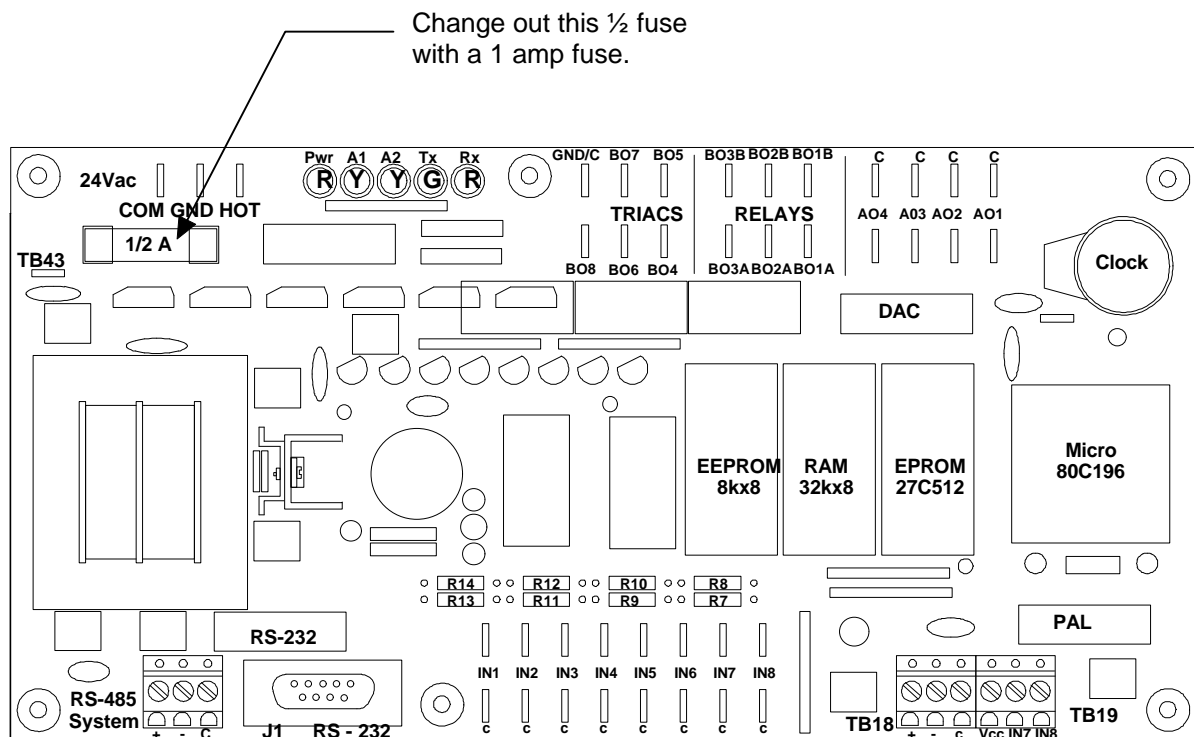
Figure 1 - ASIC/2-8040 Board Layout

Our original specification for the ASIC/2-8040 required a ½ amp fast blow fuse for the controller power circuit. We have received reports from the field that the ASIC/2-8040 fuse is blowing unnecessarily. Through engineered testing, and within accordance of our UL mark, we have determined that the rating of the fused should be increased. Therefore, our latest specification requires a full 1 amp fuse.

All controllers to date have been shipped with the ½ amp fuse installed. If the controller is performing well there is no need to change out the fuse. However, if you are experiencing frequent fuse blows then we suggest changing out the fuse to 1 amp.
