CASE STUDY

Lincoln Harris Office Plaza

Facility Multi Tenant Office, 32-Story Building

HVAC Systems Description: 3 Chillers, Floor Level SCU's with Electric Reheat

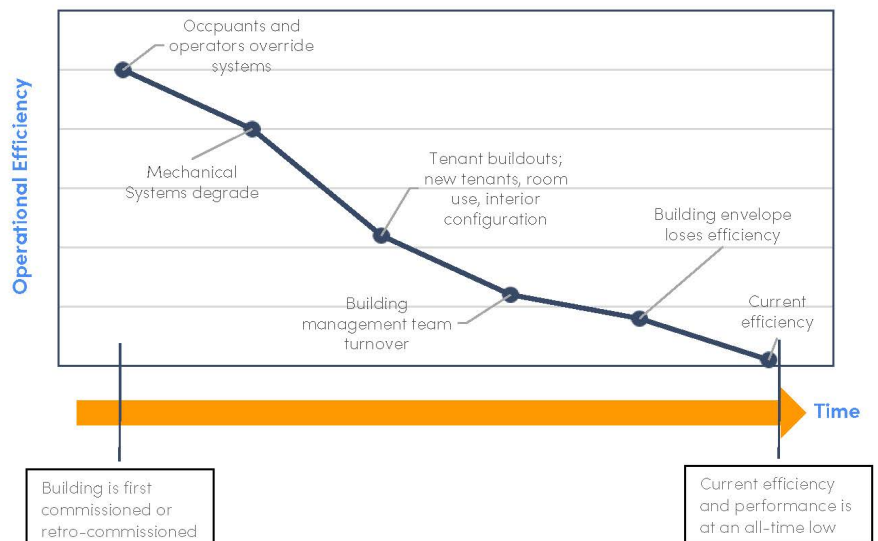
How operational efficiency decreases over time due to building drift

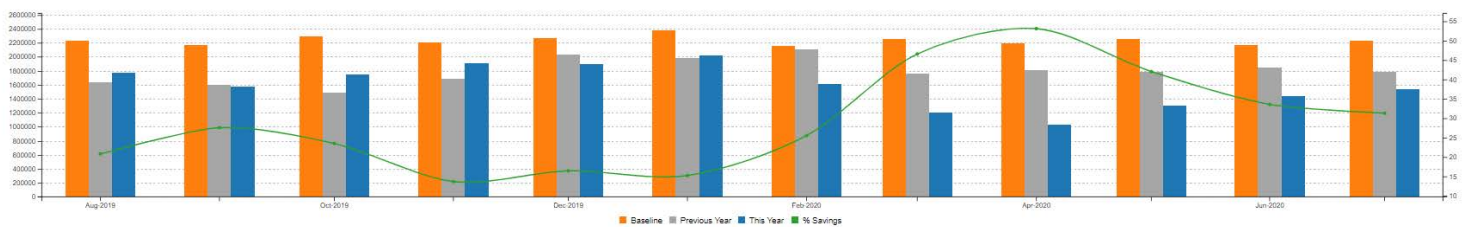
Energy Consumption Trends

In this visualization, compare for each month the orange bars (the Baseline energy spend) to the blue bars (the current years energy spend).

From the energy baseline we created from 2017 bill data to the fully retrofit and retro-commissioned bill data of 2020, West Trade has seen an average month-to-month comparison of 40% energy savings. About half of the savings can be attributed to the upgraded equipment, but the other half can be directly attributed to the first 10 months of 2020 when the Lincoln Harris team used the Platform to fine tune the building for maximum performance an efficiency.
