## ASIC/2-7540 Firmware Upgrade

Affects: ASIC/2-7540

Note No. TE-030

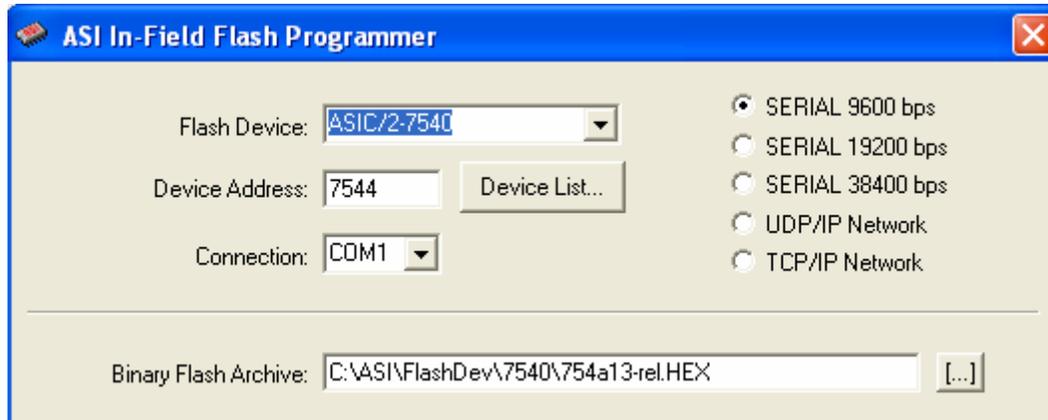
Start FlashDev.exe. FlashDev.exe expects to run from and find its files in c:\ASIFlashDev\.

The first time you run it you will need to set the operating parameters.

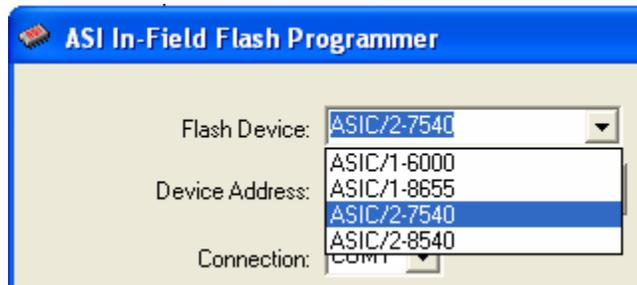
## Select Product

Select the product to be downloaded. You MUST select the proper product.

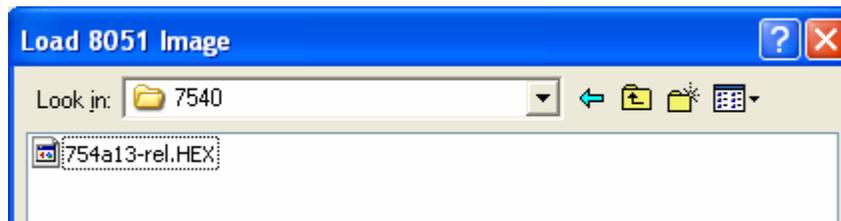
## Select Hex file

Select the firmware Hex file to be downloaded.

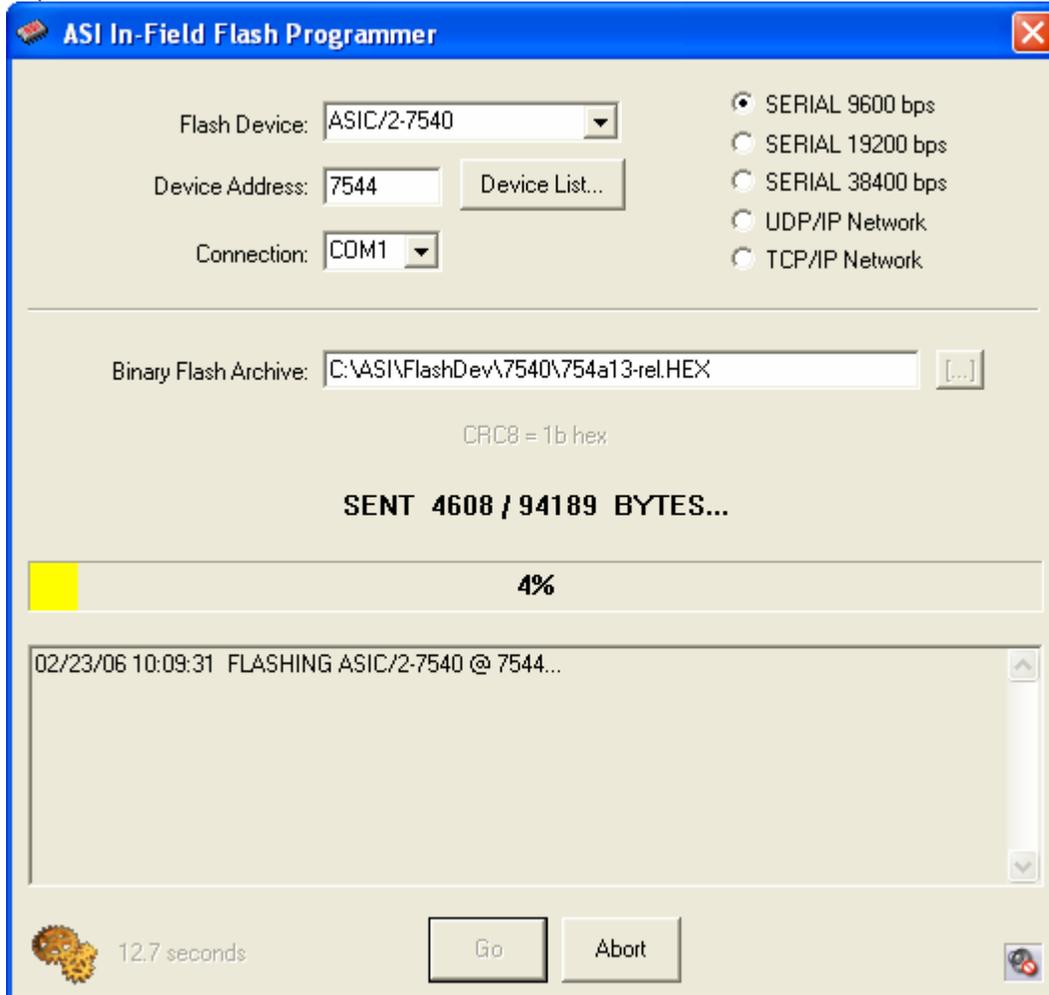
## Go

Press Go to start the download. FlashDev then downloads the file to the controller. Expert must be at Home or Closed to release the Com Port.

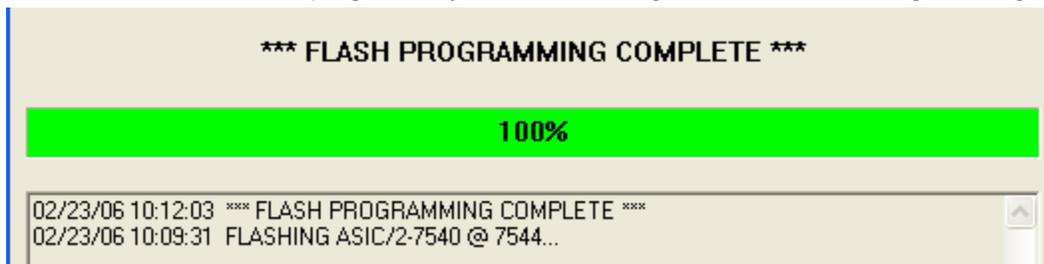
The status bar shows the progress in yellow and turns green when Flash Programming is Complete.
